# » Local Grid Incident in Rogowiec (Poland) substation on 17 May 2021

ICS Investigation Expert Panel » Final Report » 18 March 2022

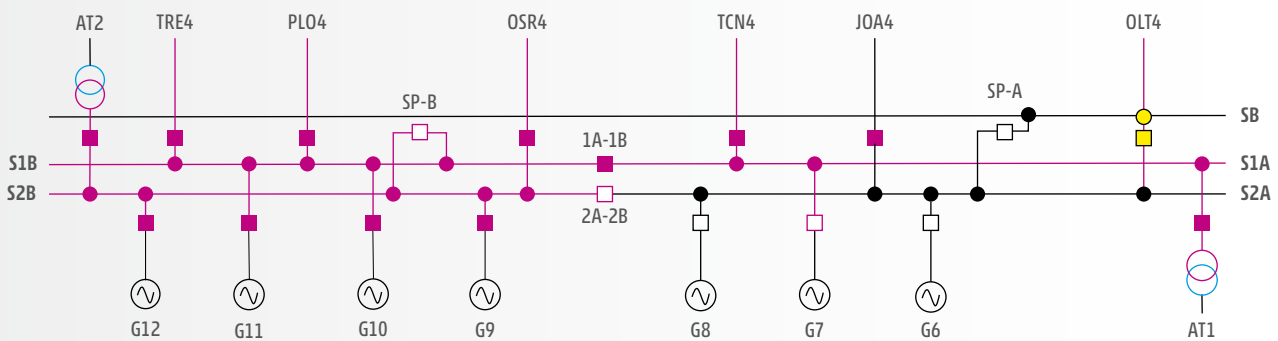
Figure 5: Line diagram of R-400 kV substation Rogowiec after the incident (black - no voltage).

As a result of the tripping of the circuit breakers of the busbar section's coupler of system 2 (2A-2B) and the busbar coupler B (1B-2B), the R-400 kV Rogowiec switchyard was divided into three electrical nodes:

- » system 1: remained loaded – closed busbar section's coupler of system 1 (1A-1B). Lines that remained connected (loaded): Trębaczew (TRE4), Płock (PLO4) and Tucznawa (TCN4). 400/220 kV autotransformer AT1 tripped from one side in the R-220 kV Rogowiec switchyard. Tripped lines: PGM BEL\_4-07, PGM BEL\_4-10 and PGM BEL\_4-11;
- » system 2A: de-energised. Tripped lines: PGM BEL\_4-06 and PGM BEL\_4-08, 400 kV Rogowiec (ROG4) – Ołtarzew (OLT4) and Rogowiec (ROG) – Joachimów line circuit 3 (JOA4) tripped on one side, respectively at the R-400 kV Ołtarzew and R-400 kV Joachimów switchyards;
- » system 2B: remained energised. Ostrów line remained connected (OSR4). 400/220 kV autotransformer AT2 tripped from one side in the R-220 kV Rogowiec switchyard. Tripped lines: PGM BEL\_4-09 and PGM BEL\_4-12.

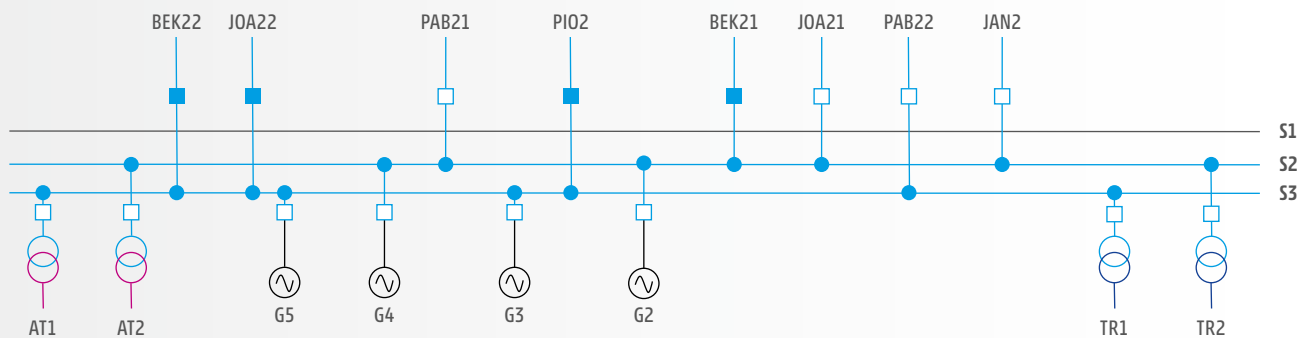
Figure 6: Line diagram of R-220 kV substation Rogowiec after the incident (black - no voltage).

The R-220 kV Rogowiec switchyard still operated as two separate electrical nodes.

- » system 1: de-energised.
- » system 2: remained energised. The Bełchatów Kopalnia line circuit 1 (BEK21) remained connected. Tripped elements: PGM line BEL\_2-02, PGM line BEL\_2-04, PP's auxiliary transformer TR2, 400/220 kV autotransformer AT2, Pabianice line circuit 1 (PAB21), Janów line (JAN2) and Joachimów line circuit 1 (JOA21);
- » system 3: remained energised. Lines that remained connected: Piotrków (PIO2), Joachimów circuit 2 (JOA22) and Bełchatów Kopalnia circuit 2 (BEK22). Tripped elements: Pabianice line circuit 2 (PAB22), PGM line BEL\_2-03, PGM line BEL\_2-05, PP's auxiliary transformer TR1 and 400/220 kV autotransformer AT1.

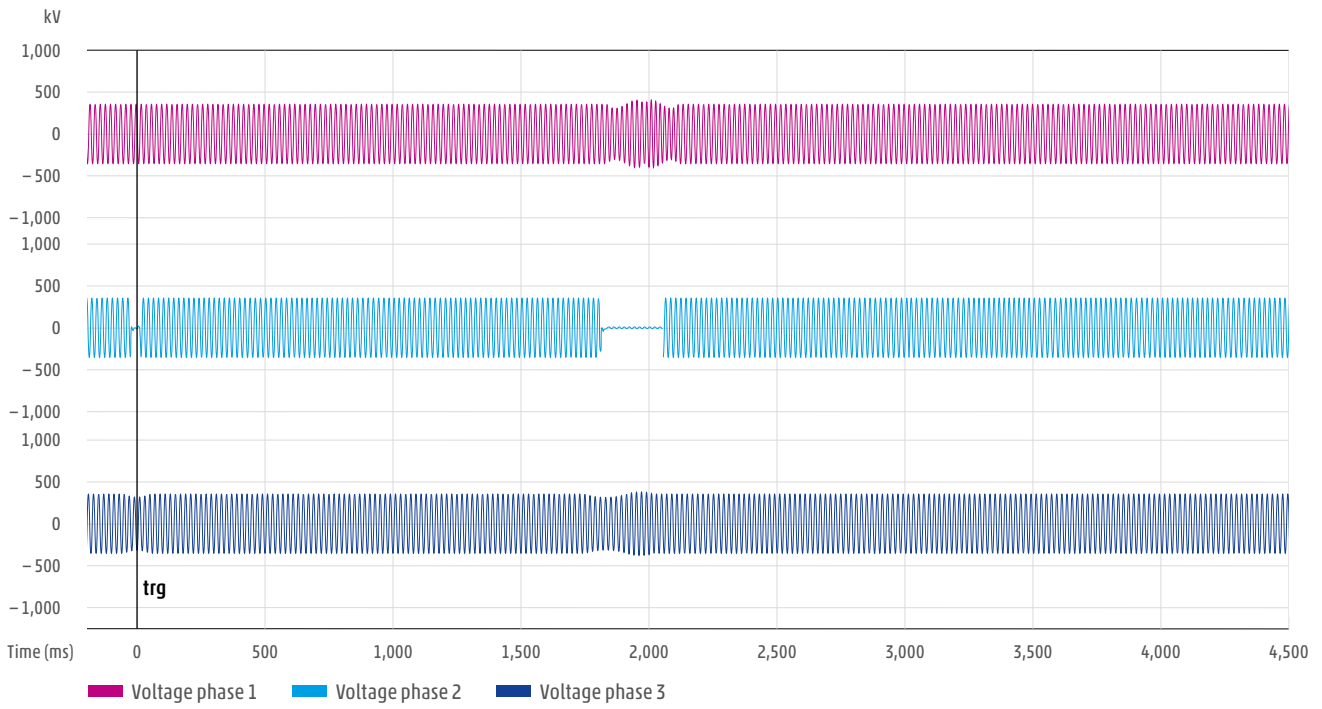
Figure 9: Voltage diagram in the R-400 kV Rogowiec substation - SP-B busbar coupler.

At 16:34:09, the 400 kV busbar coupler SP-B detected one phase (L2 phase) voltage drop which was caused by a short circuit current generated by the mistaken closure of phase L2 of the line earthing switch at 400 kV Line Rogowiec – Ołtarzew. The disturbance was correctly cleared by tripping phase L2 circuit breaker by

the protection devices at line, responding to a 1-phase short-circuit, which was followed by the activation of auto-reclose. The second voltage drop (after 1.8 s) detected by SP-B was caused by the reclosure of the circuit breaker of 400 kV Line Rogowiec – Ołtarzew (result of the auto-reclosure). Busbar coupler SP-B switched off and divided substation into 2 nodes – both nodes have the nominal voltage.

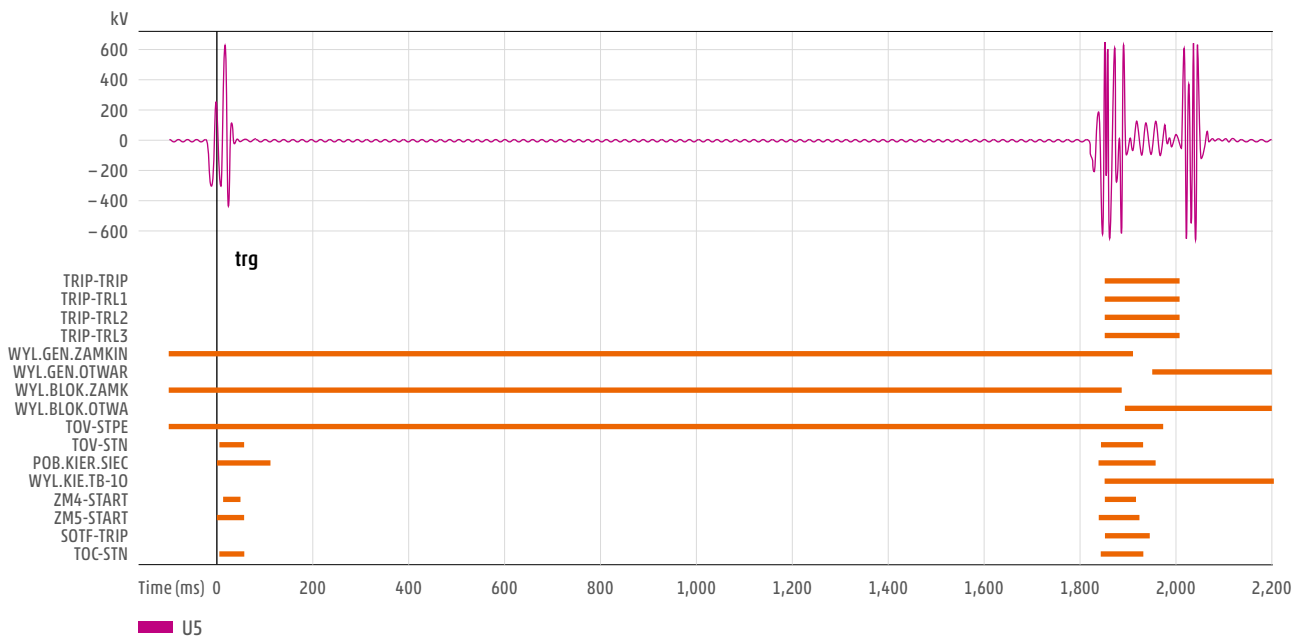
Figure 11: Protection signals from the PGM BEL\_4-10 line at the Rogowiec substation.

Protection devices of the TPP Bełchatów PGMs noticed several signals from protection devices. After the first one phase L2 short circuit, cleared by protection devices, PGMs (at figure 11 PGM BEL\_4-10 as example) had not received signal SOTF-TRIP.

Approximately 2 seconds later all 10 PGMs in Bełchatów received several signals about disturbance in the system and, among the others, the signal SOTF-TRIP, which caused immediate disconnection from the system.

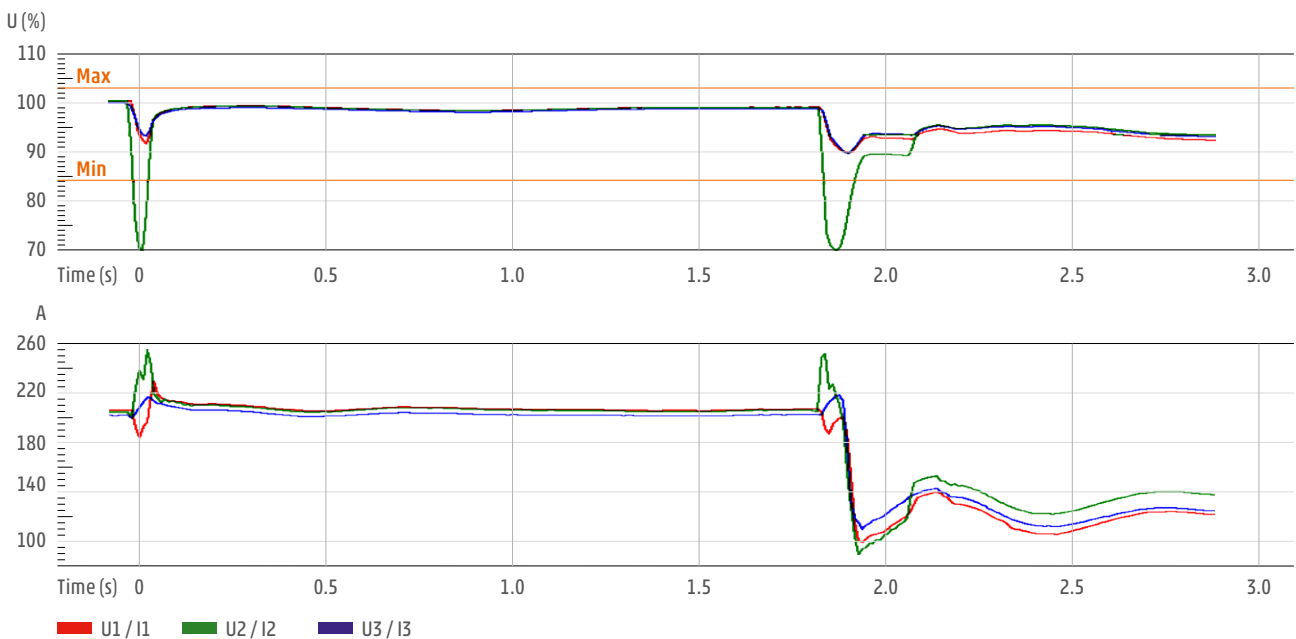
Figure 12: Voltage (RMS) in the R-220 kV Janów switchyard.

Protection devices at the neighbouring substations noticed cleared one phase L2 short circuit current and voltage drop. After ca. 2 seconds, the final tripping of the several circuit breakers in Rogowiec at both substations (R-400 kV and R-220 kV) stabilised the situation in the grid.

Figure 12 presents the voltage and current observed in line protection devices during the incident in the R-220 kV Janów switchyard at the 220 kV line Janów - Rogowiec (JAN2 at the Figure 6). Line disconnected one sided at R-220 kV Rogowiec.
