UCTE

Interim Report
System Disturbance on 4 November 2006
union for the co-ordination of transmission of electricity

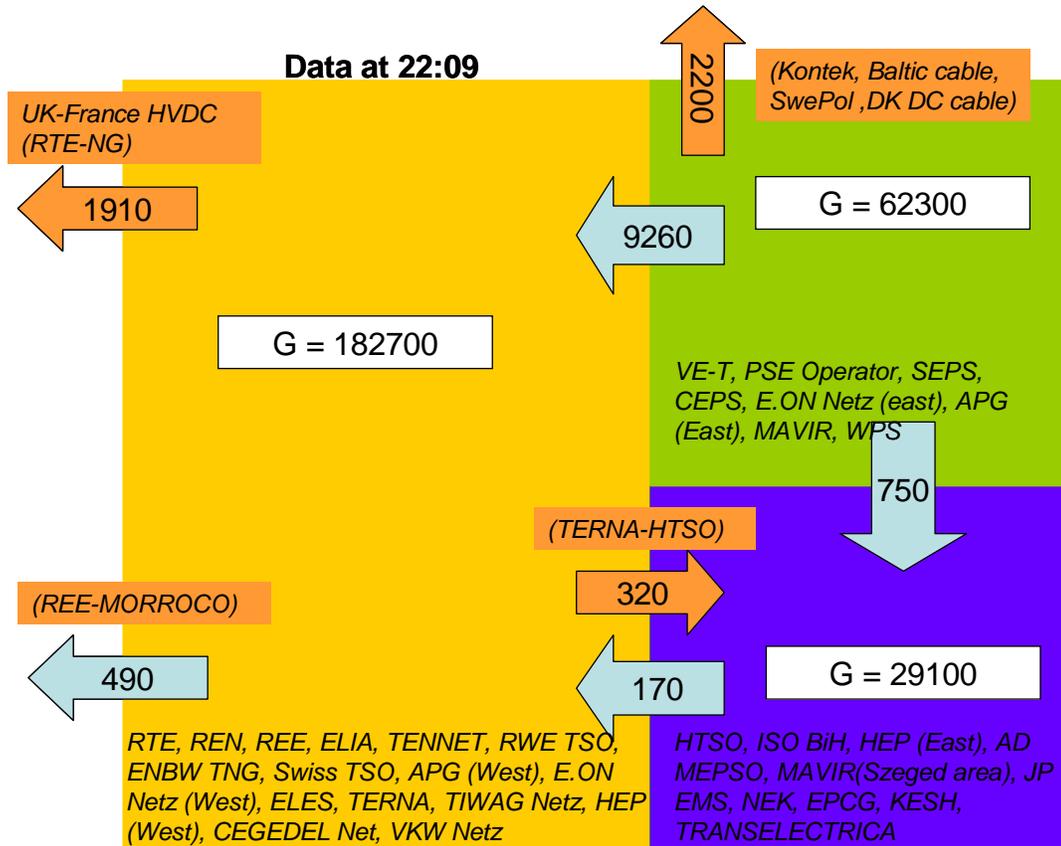
Figure 1: Generation and power flows between the 3 areas just before splitting 4 November 22:09

The following figure shows the estimated generation (G), the sum of physical exchanges on the lines which tripped in the course of the incident (blue arrows) and exchanges over DC cables (orange arrows).

As presented in Figure 1, the power balance in each area at the splitting time was no longer ensured. About 9 500 MW which came from the East area to the Western area was cut and those areas could not ensure the balance any more. Therefore the frequency sharply dropped at about 49 Hz in the Western zone due to the sudden lack of power.

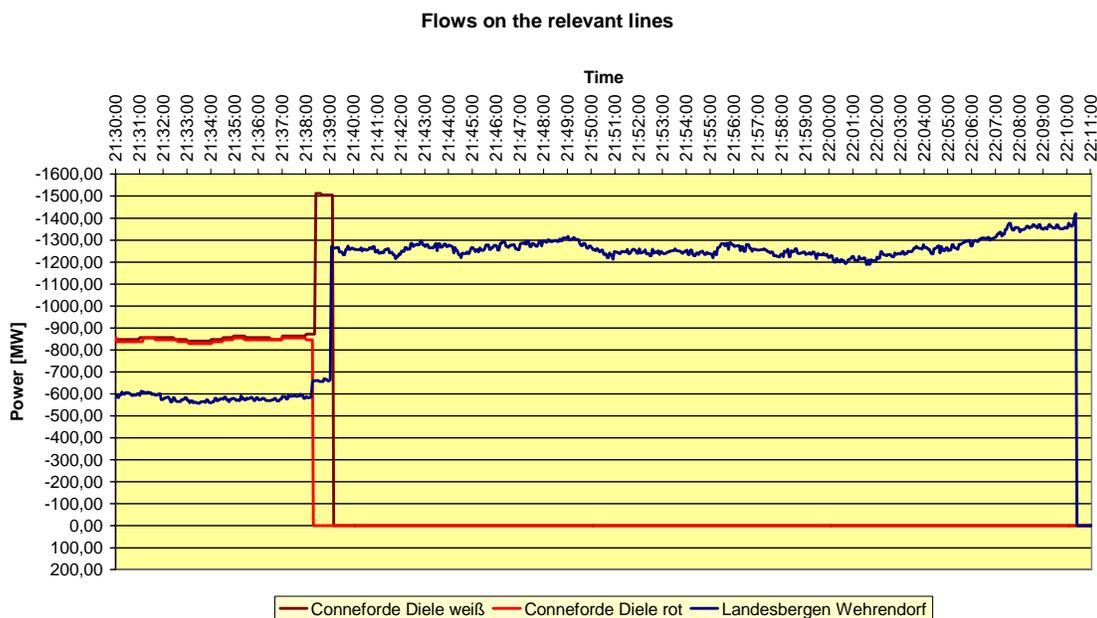
Figure 3: Power flow on the Landesbergen-Wehrendorf line before and after Conneforde-Diele switching off

The increase of the flow on the critical line up to the moment of tripping is shown in Figure 3 below. The manual switching of the Diele–Conneforde line at 21:38 resulted in a significant increase (over 600 MW) in the power flow on the Landesbergen-Wehrendorf line. The loading of this line exceeded 1200 MW close to the secure limit for RWE TSO. At around 21:50, a small decrease (about 100 MW) can be observed, however at around 22:02 the loading gradually increased. The line tripped immediately after coupling the busbars in Landesbergen. This tripping led to cascading line trippings all over the UCTE area. All lines tripped due to overloading that triggered distance protection. These line trippings are listed in Appendix 3.

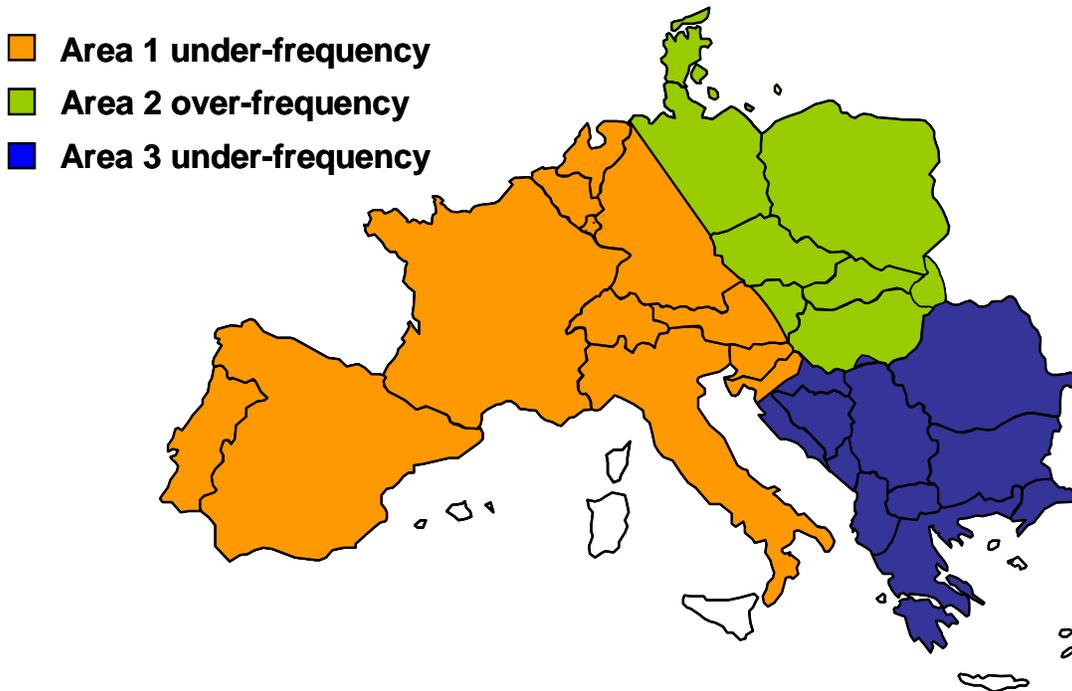
Figure 4: Schematic map of UCTE area split into three areas

The list of TSOs in each area is given in Appendix 4.

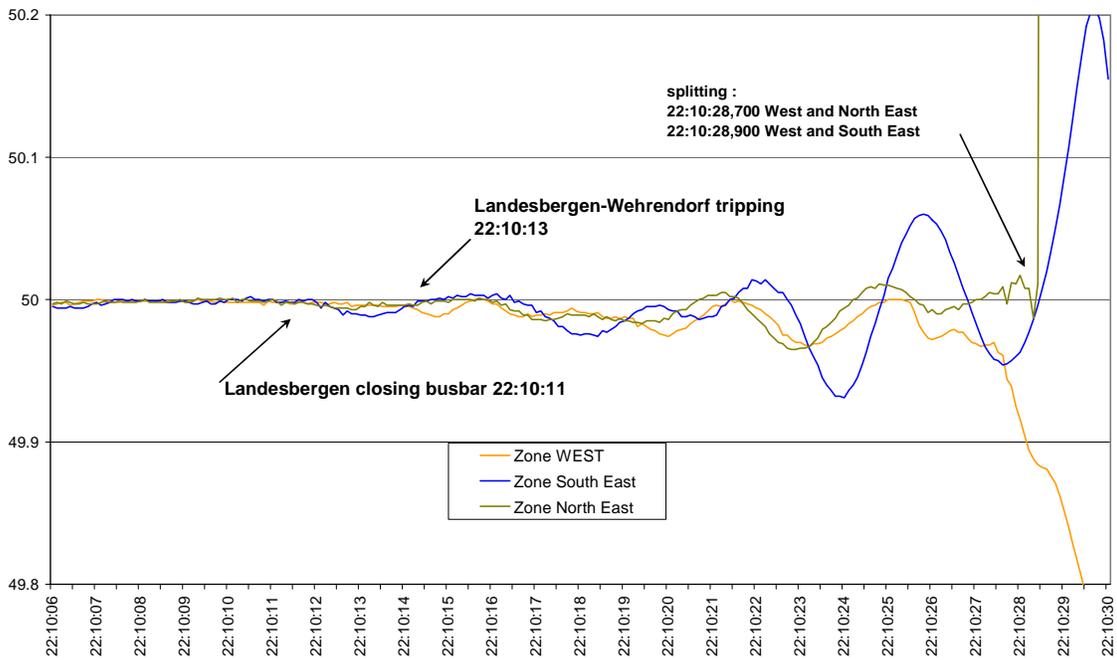
Figure 5: Frequency recordings until area splitting

Figure 5 (below) shows the frequency recordings retrieved by Wide Area Measurement Systems (WAMS) in the three areas from 22:10:06 to 22:10:30. The time stamps of the manual switching in the Landesbergen substation, the tripping of the Landesbergen-Wehrendorf line as well as the time stamp when the splitting of the areas was completed are indicated. The manual switching in the Landesbergen substation triggered frequency oscillations which continuously increased as different lines were tripped. It is worth mentioning that the frequency oscillations in area 3 were initially more intense.

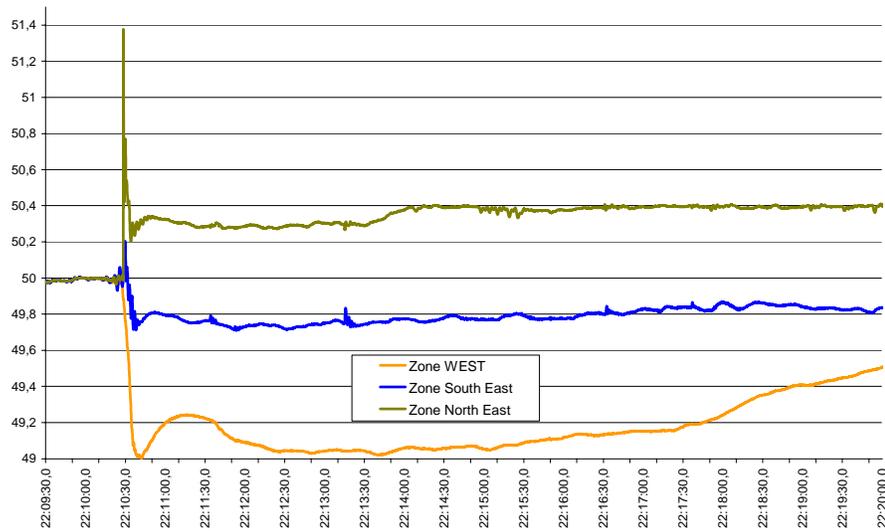
Figure 6: Frequency recordings after the split

Figure 6 is presenting frequency recordings as retrieved by Wide Area Measurement Systems (WAMS) in the three areas from 22:09:30 to 22:20:00

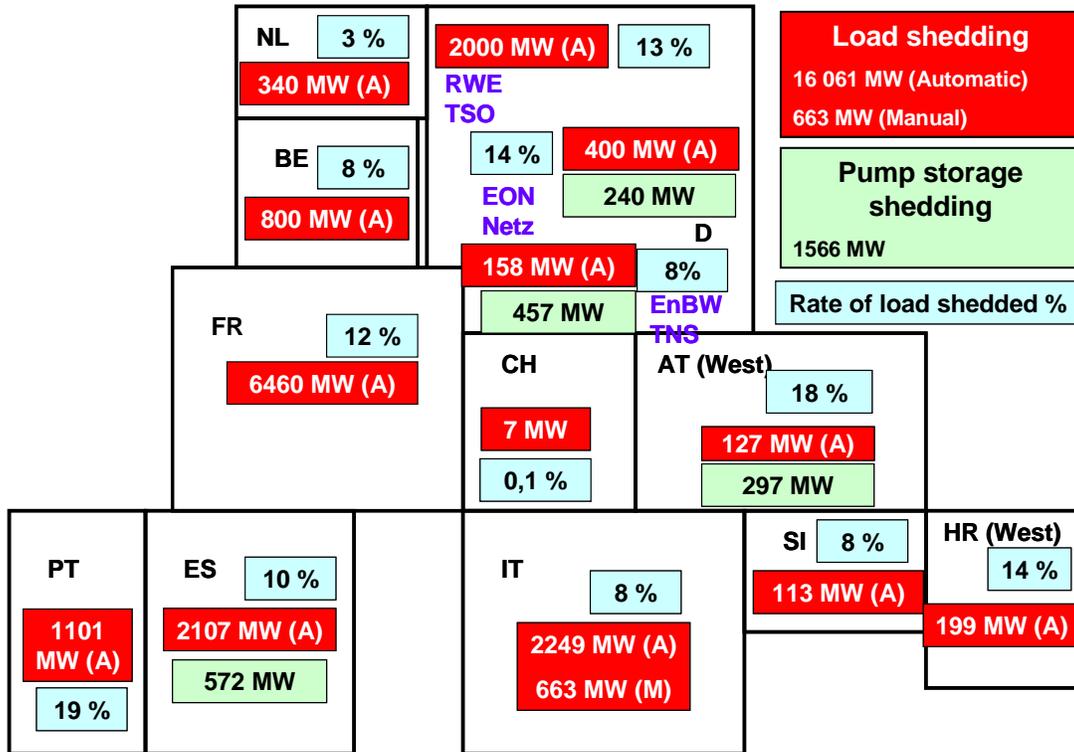
Figure 7: Map of load and pumped-storage shedding by TSOs

In red square, the total of automatic (A) load shedding separated of manual (M) load shedding. The value in the blue square is the rate of load shedding and pump shedding related to the total estimated total load (or load in the TSO grid, where the total load cannot be determined at the moment). The values in green squares show the automatic pumps shedding (which can be activated according to the defense plan). This action has been made only by a few TSOs due to the hour of the incident (just after 22:00) when most of the pumps were not yet in operation.

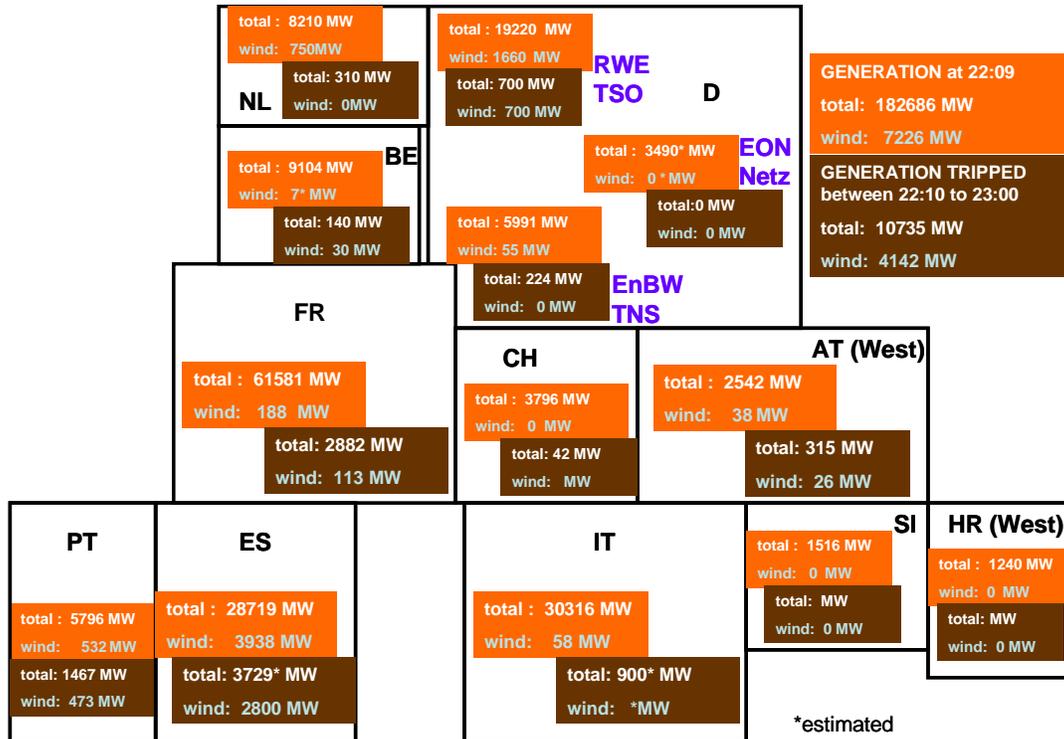
Figure 8: Map of generation tripped (total and wind)

In the Western area, a total of about 10 700 MW tripped (see details in Figure 8).

The orange squares show the total of generation units started and the wind generation started just before the incident (22:09). The brown squares show the generation units tripped due to the frequency and voltage drop.

page 26, Figure 8
to be added: Generation tripped in HR (West): 200 MW;
and accordingly: Generation tripped, total: 10 935 MW

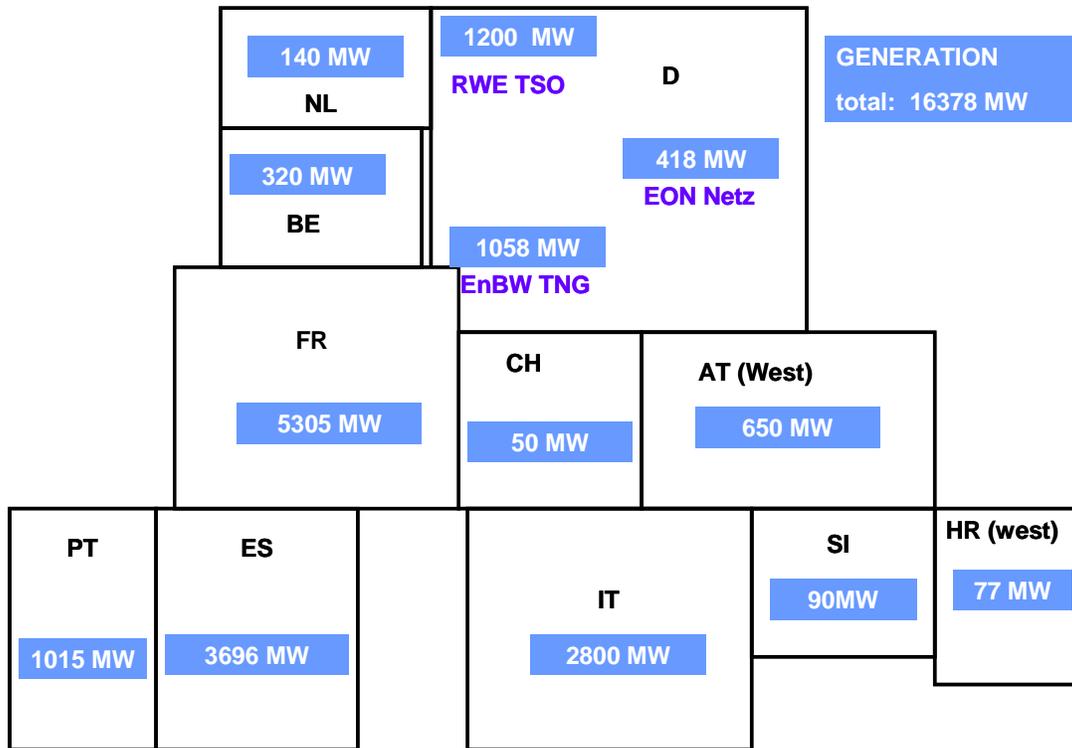
Figure 9: Generation units started by TSOs

The details of generation units started by TSOs are shown in the Figure 9.

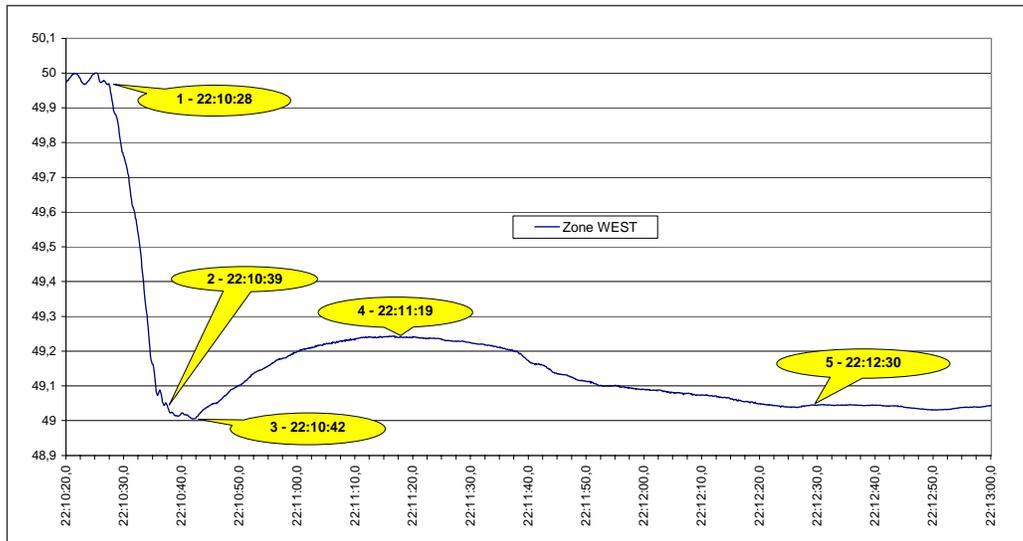
Figure 10: Frequency in the Western area

For preliminary explanations of the frequency curve during the first minutes after the incident, please refer to Figure 10 focusing on the time range from 22:10:20 to 22:13.

- ① – 22:10:28, separation of the Western area from the Eastern part of UCTE
- ② – 22:10:39, stop of frequency decrease, mainly due to the action of defense plan
- ③ – 22:10:42, beginning of frequency increase caused by primary reserve
- ④ – 22:11:19, frequency maximum at a value near 49.2 Hz
- ⑤ – 22:12:30 slow frequency raise to reach a normal value of 50 Hz at about 22:25

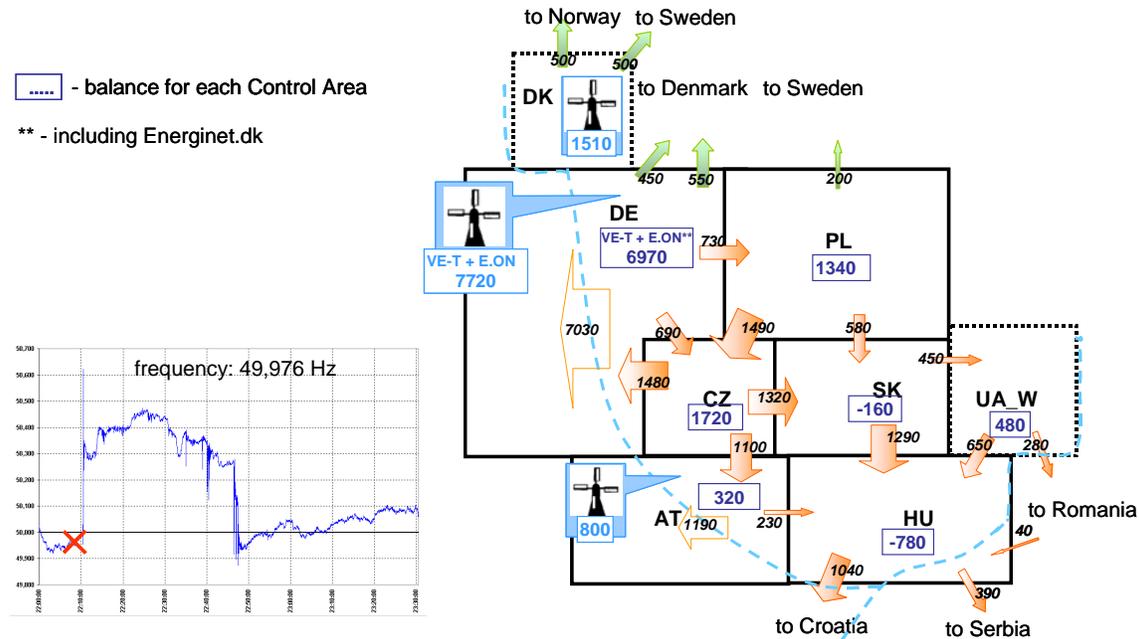
Figure 11: Intersystem power flows in area 2 at 22:09

After cascading trippings of overloaded lines leading to the splitting of the UCTE power system into three large separate areas, the North-East area (see Appendix 4 for composition of the area) faced severe imbalance conditions with a generation surplus of more than 10 000 MW (approx. 17% of total generation in this area before the splitting leading to a situation of high over-frequency. The imbalance was attributable to the fact that before splitting there was a huge transit of electricity from this area towards the West and South of Europe. This is a typical load flow situation in this region, but on this day the volumes of flows were increased as compared to standard days due to high wind conditions in the North of Germany (see Figure 11: Intersystem power flows in area 2 at 22:09).

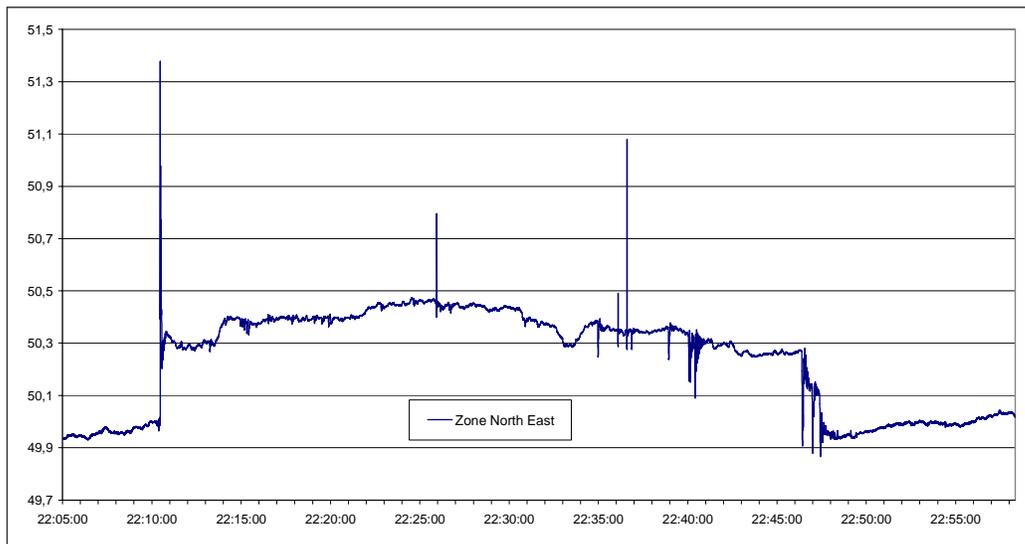
Figure 14: Frequency in area 2 (22:00 – 23:00)

ensured steady decrease of generation in most of the thermal power plants of the region, which were able to decrease their output. This was not the case in many thermal units in VE-T control area, which operated close to their minimums already before the disturbance (due to high wind conditions) and thus were not able to contribute to frequency decrease after it. The dispatchers of PSE-O, acting as a CENTREL control block leader, apart from decreasing generation within Poland also approved other CENTREL TSOs (CEPS, SEPS, MAVIR, WPS) deviations from planned exchange programs instructing them at the same time to further decrease the generation within their control areas. In total, at 22:35 the CENTREL power systems together absorbed about 58% out of the initial overcapacity of approx. 10 000 MW in the whole area 2 (mainly PSE-O: 35%, CEPS: 20%), while the other power systems of area 2 absorbed together 32% (VE-T + E.ON Netz: about 23%, APG: 9%). The remaining initial overcapacity roughly estimated at about 10% resulted in an over-frequency of 50.37 Hz (the frequency slowly raised from 50.3 Hz at 22:13 up to 50.45 Hz at 22:28 and then slowly decreased to about 50.3 Hz before resynchronization – see Figure 14 – chart of frequency in area 2).

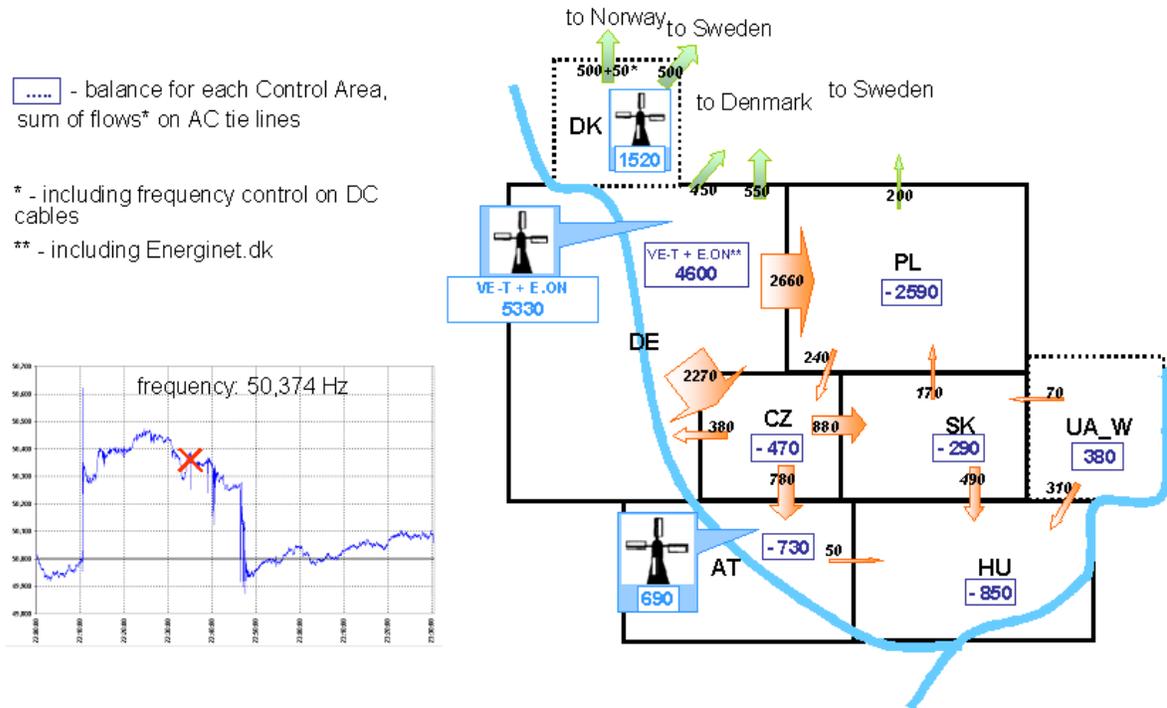
Figure 17: Intersystem power flows in area 2 at 22:35

This uneven absorption of the initial surplus of generating capacity within area 2, which mainly resulted from the reconnection of windmills in the North of Germany, led in turn to significant changes in power flows within area 2. As indicated above, the power flows established in a new steady state just after the disturbance were within acceptable limits but with the gradual increase of wind generation and decrease of thermal generation after 22:10 these flows started gradually to change. Generally the process was featured by an increase of generation in the North of Germany (windmills) and decrease of output of thermal plants in the whole area, but mainly in Poland and the Czech Republic resulting in increasing flows from VE-T to PSE-O and CEPS, while other tie lines in the region experienced lower loadings than usual. Already at 22:20, the flows on VE-T/PSE-O and VE-T/CEPS profiles exceeded the transfer capacities on these borders acceptable in normal operating conditions⁹ (see Figure 15 Intersystem power flows in area 2 at 22:20) and continued to increase further till 22:35 when it reached unacceptable levels even for emergency conditions (see Figure 16: Intersystem power flows in area 2 at 22:30 and Figure 17: Intersystem power flows in area 2 at 22:35).

These flows led to overloading of internal lines in the south of the VE-T control area (double circuits of 380 kV line Barwalde - Schmoln for a few seconds up to 126 % of the permanent transport capability), southwest of Poland (400 kV line Mikulowa - Czarna was overloaded up to 120 %, both 400/220 kV transformers in Mikulowa substation were overloaded to more than 120%) and west of Czech Republic (400 kV line Hradec - Reporyje was overloaded up to 140 %) - see Figure 18: Overloaded elements in the region of VE-T/PSE-O/CEPS borders and Figure 19: Example of critical load flows: VE-T / PL + CZ profile and Figure 20: Overloads on 400 kV Mikulowa-Czarna internal PSE-O line).

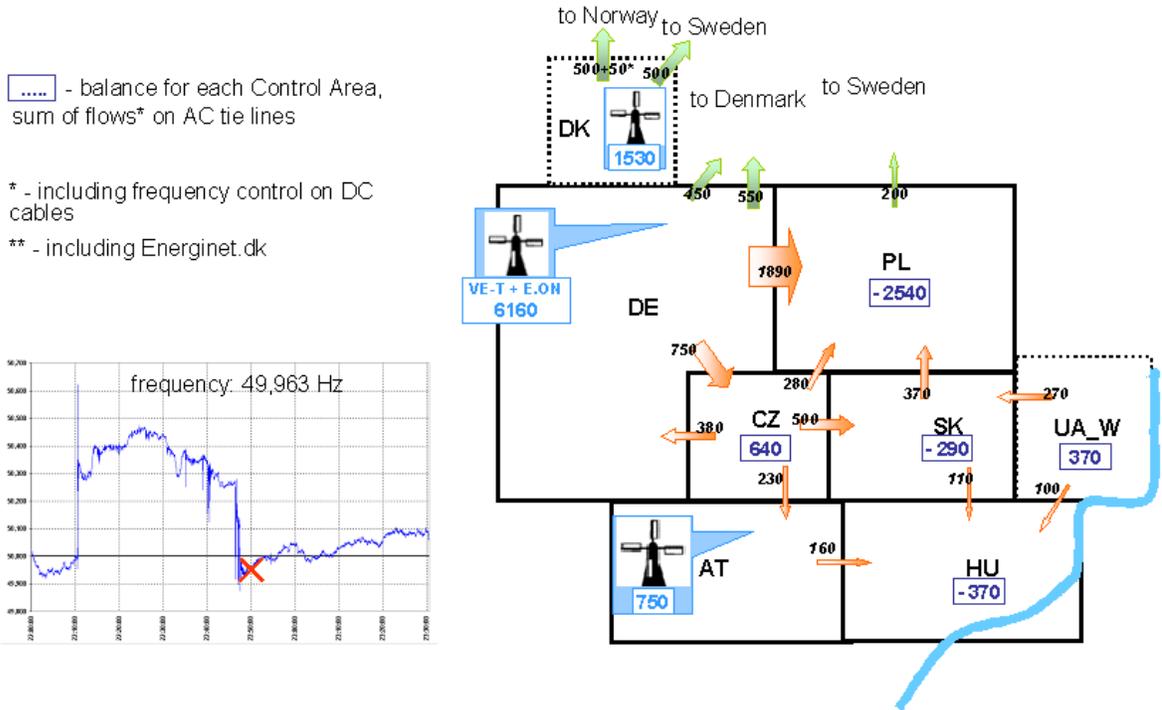
Figure 21: Intersystem power flows in area 2 at 22:50 (critical W-E flow just after synchronization in DE and A; decrease of W-E flow)

The N-1 rule was not fulfilled at that time in this region of VE-T/PSE-O/CEPS borders and tripping of any element in this region (especially overloaded ones) would lead to further overloading and possible cascading tripping. This was a real danger of further splitting of UCTE power systems. However, the cooperation between the control centers of involved TSOs allowed first to relieve the overloadings for some minutes (increase of generation in the southwest of Poland, usage of complex control on transformers in the Mikulowa substations, additional pumps started and thermal generation decreased in the VE-T control area) and then finally the successful resynchronization of area 1 with area 2 in Germany and Austria at 22:47 decreased the flows in this region to acceptable levels within half an hour (see Figure 21: Intersystem power flows in area 2 at 22:50 (critical W-E flow just after synchronization in Germany and Austria; decrease of W-E flow). At 23:30 the power systems in central Europe came back to normal operational conditions (see Figure 22: Intersystem power flows in area 2 at 23:30 (back to normal operational conditions)

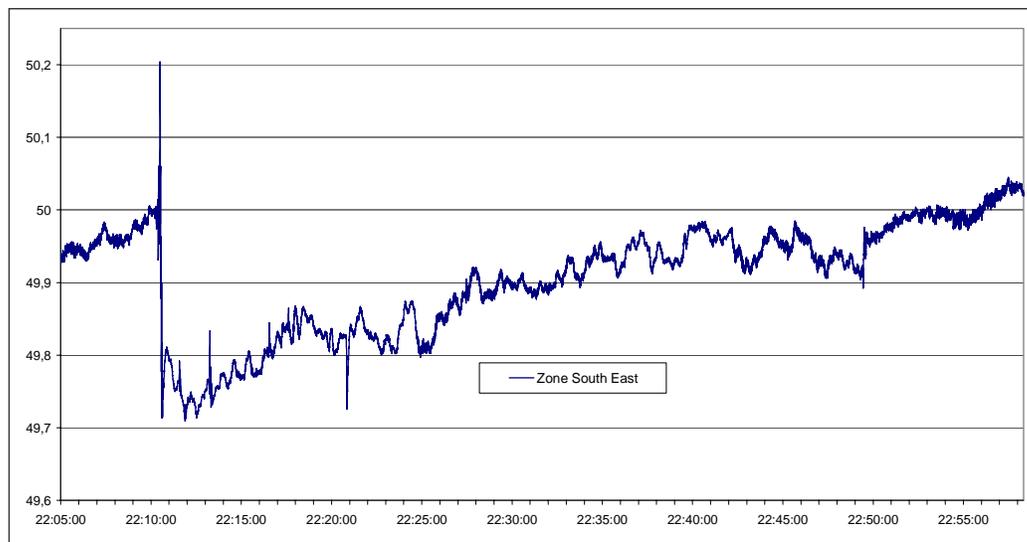
Figure 23: Frequency evolution in area 3 during the event (WAMS recording)

At 22:14:17, due to the low frequency, the automatic generation control mode of the HTSO (GR) was changed from load frequency control¹¹ to pure frequency control¹². At 22:30, 2 hydro units in Croatia (HR) started up: HE Zakučac-220 kV with 47 MW and HE Zakučac-110 kV with 55 MW. Due to the automatic generation control of Greece, using the available secondary reserves and the additional increase of generation in Croatia, frequency was back in the acceptable range (49.982 Hz) as shown in Figure 23, at 22:40:36.

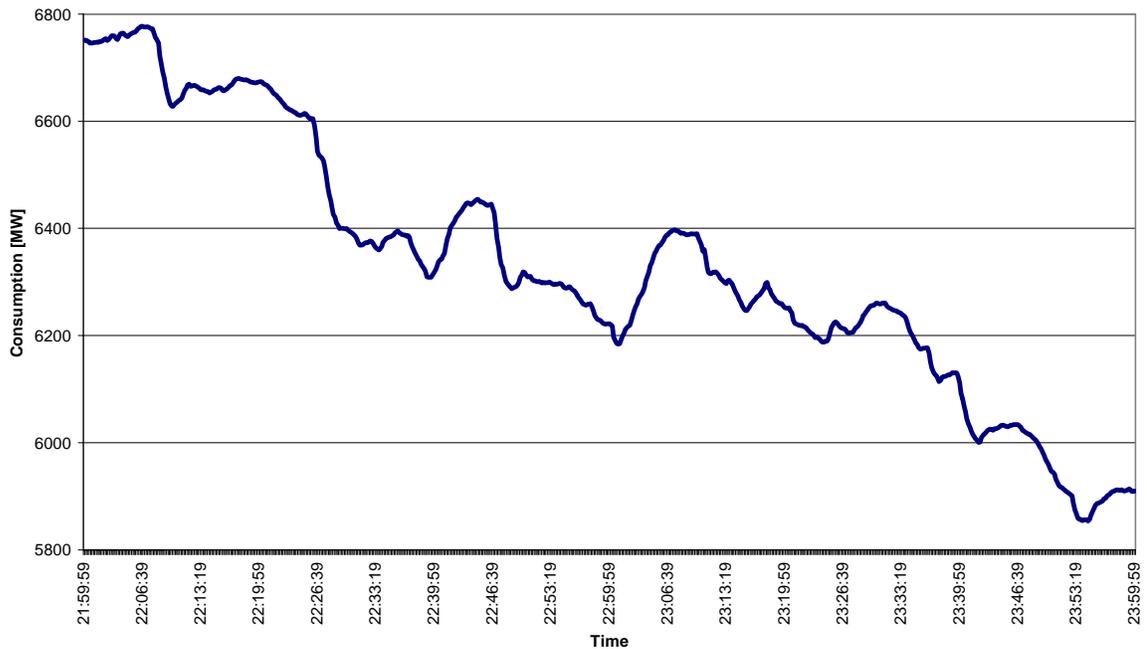
Figure 24: Evolution of consumption in the HTSO area during the event (no load shedding in the area)

The power exchange on the DC link between Italy and Greece (capacity of 500 MW), scheduled at 312 MW towards Greece, was not interrupted during the whole event. Fortunately, there was no need from the Italian side to interrupt this program (in a different case, Greece would have faced an additional deficit of 310 MW). Moreover, the time frame of the event coincides with a period when load rapidly decreases in the Southeast area. An indicative example is given in Figure 24 (total consumption in HTSO area during the event).

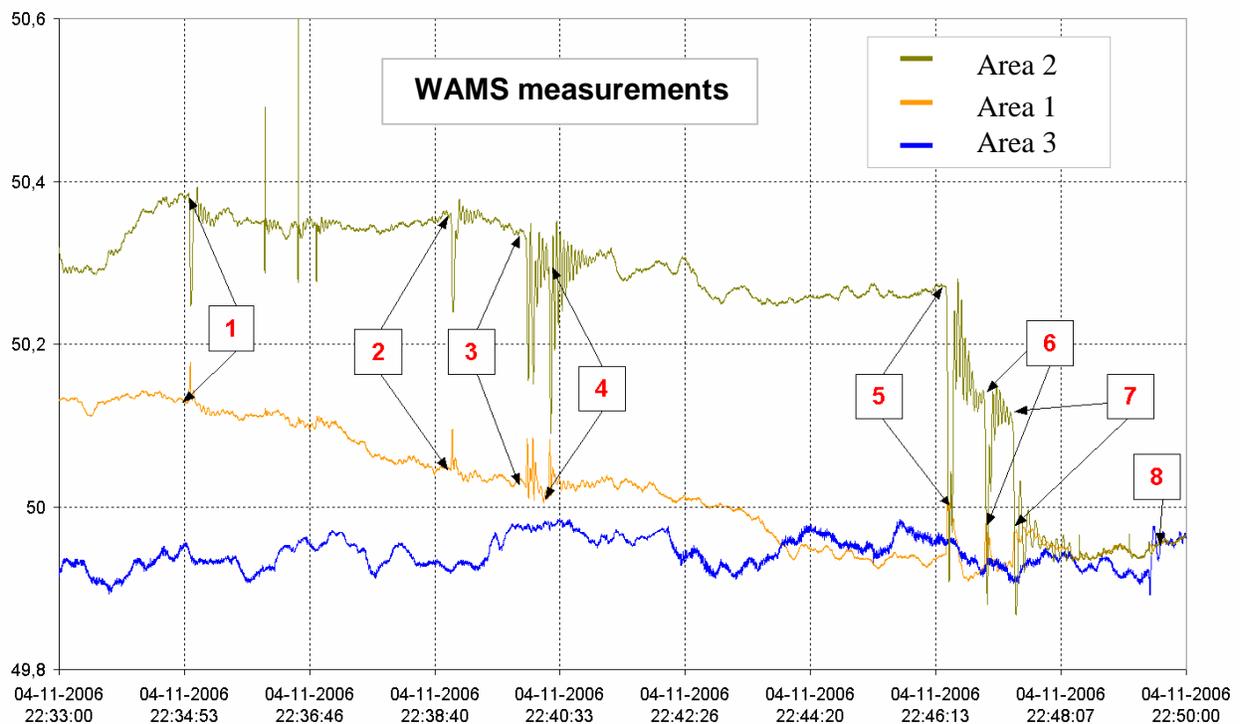
Figure 25: Frequency recordings for three areas

Classification of actions to the above grouping is based on the WAMS measurements of frequencies in split areas (each measurement point with exact GPS time stamp, 100 msec resolution) See Figure 25 Frequency recordings for three areas.

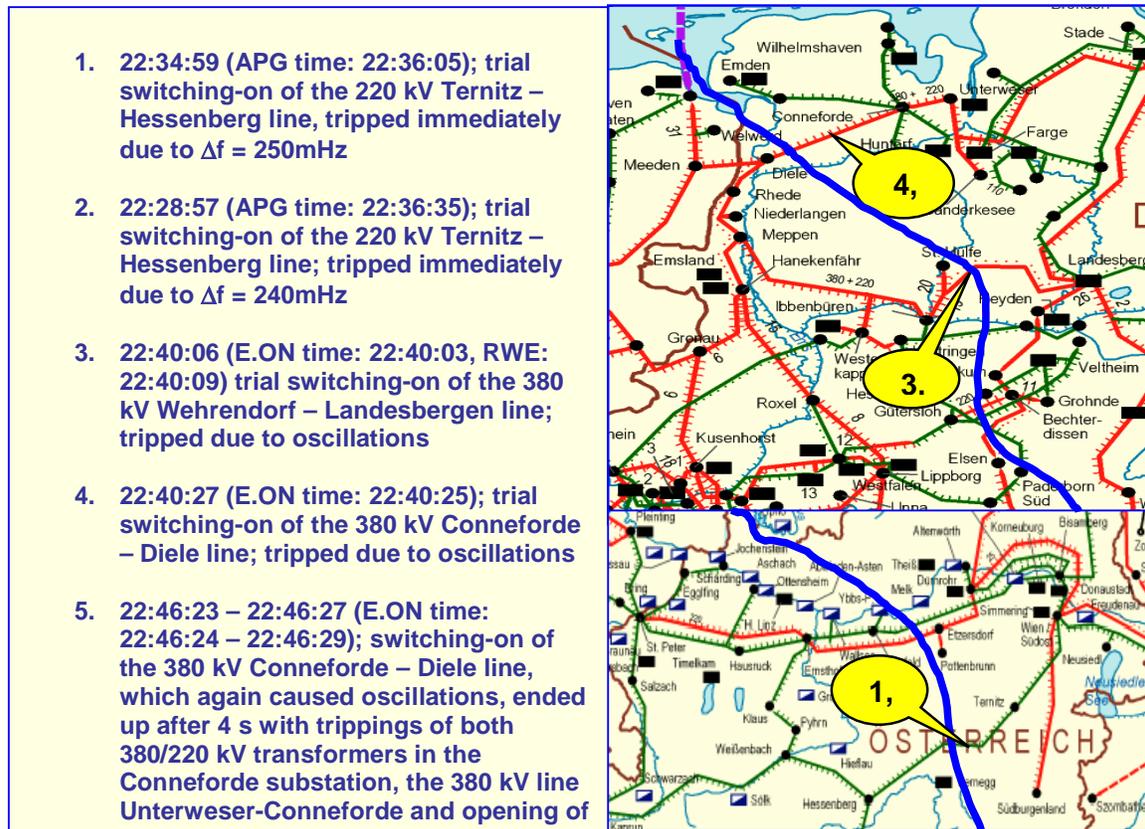
Figure 26: Unsuccessful resynchronization trials and attempts

22:46:23 - 22:46:27.3 (E.ON Netz time: 22:46:24 – 22:46:29) switching-on of the 380 kV Conneforde-Diele line, which again caused oscillations, ended up after 4 seconds with trippings of both 380/220 kV transformers in the Conneforde substation, the 380 kV line Unterweser-Conneforde and opening of the 220 kV busbar coupling in the Conneforde substation (moving the border line eastwards). The difference of frequencies was about 300 mHz [5].

22:46:57.3 - 22:47:00.6 (E.ON Netz time: 22:46:57 - 22:47:05, RWE TSO time: 22:47:03 - 22:47:09) switching-on of the 380 kV Landesbergen-Wehrendorf line which tripped due to oscillations after 3 seconds (the difference of frequencies was about 150 mHz) [6].

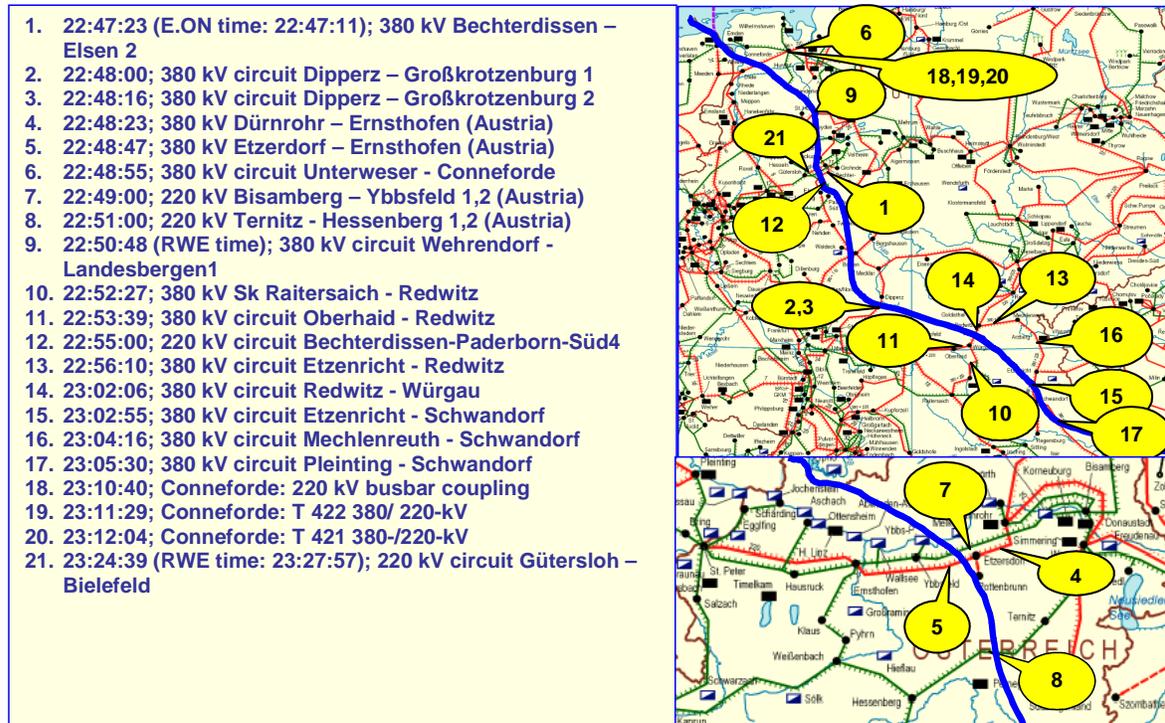
Figure 27: Resynchronization of areas 1 and 2 in Germany and Austria

Finally at 22:47:23.4 (E.ON Netz time: 22:47:11) successful resynchronization took place first on the 380 kV line Bechterdissen-Elsen (circuit 2) [7]. The recorded difference in frequencies before this connection was about 180 mHz and the phase angle difference on the line's ends was less than 10°. It is remarkable that this line is much shorter than lines in the north of Germany which failed before, and is located closer to the generation area in the western part. Following that successful trial, further lines were switched-on very quickly and after 6 minutes (at 22:53) already nine 380 kV and four 220 kV lines on the border between area 1 and area 2 were in operation in Germany and in Austria. The restoration sequence was finally finished in Germany at 23:24:39 with 17 transmission elements re-closed (in Austria re-closure of all six lines was completed already by 22:51).

Details of this phase are presented on Figure 27 Resynchronization of areas 1 and 2 in Germany and Austria.

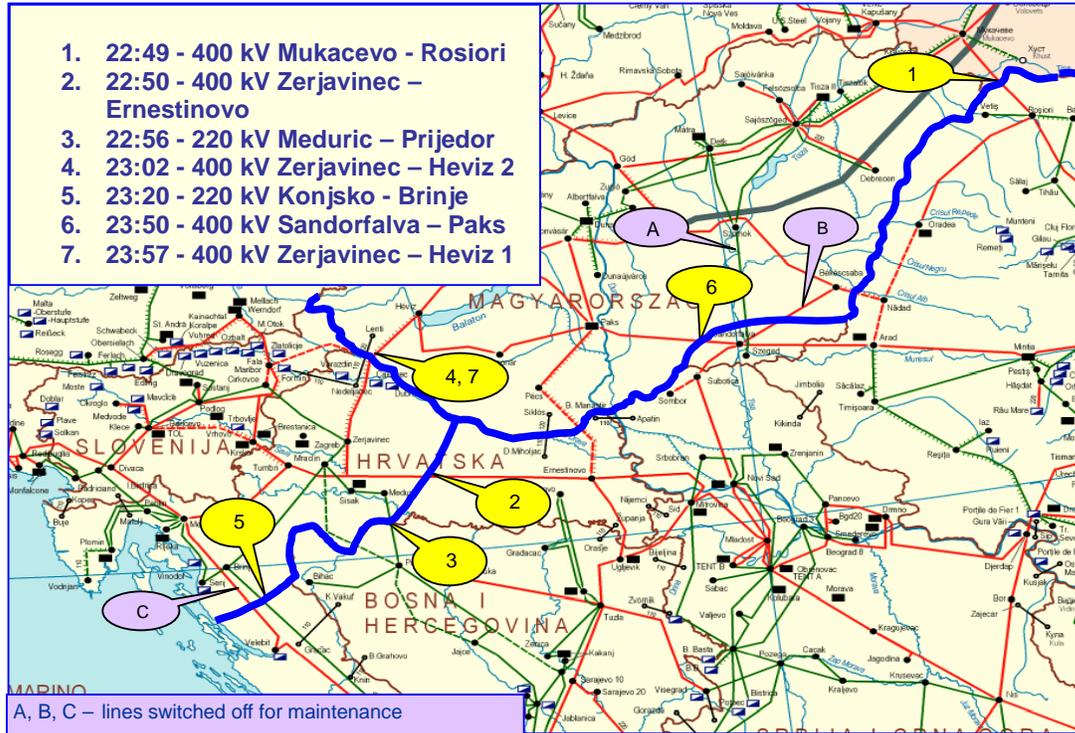
Figure 28: Resynchronization of area 1+2 with area 3 in Croatia, Hungary, Romania, West Ukraine

Details of the resynchronization phase in Croatia, Hungary, WPS with geographical reference are presented on Figure 28 Resynchronization of area 1+2 with area 3 in Croatia, Hungary, Romania, West Ukraine.

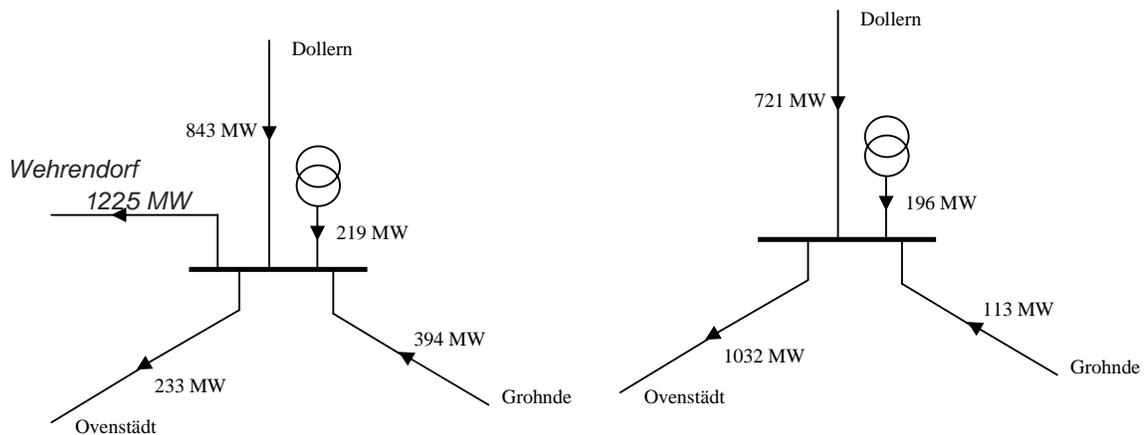
Figure 29: Landesbergen substation - Before coupling

The Figures 29 and 30 below show the power flow configuration at the Landesbergen substation before and after coupling both busbars (as if this manoeuvre had been done at 22:00).

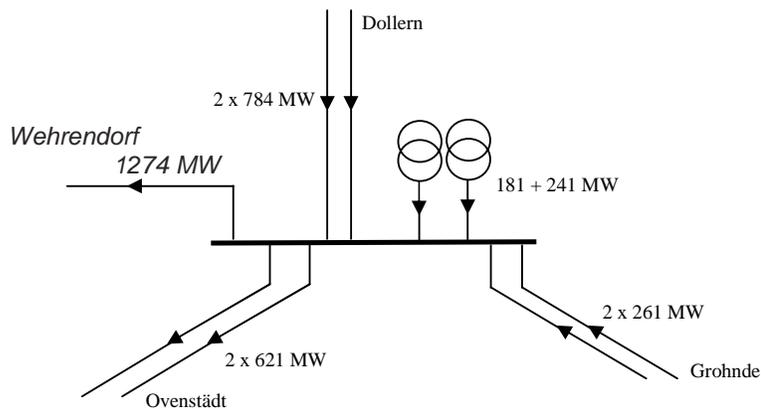
Figure 30: Landesbergen substation - After coupling both busbars

This simulation shows that the power system state is much better. The power flow over the Landesbergen-Wehrendorf line is reduced by 157 MW (221 A), that is about 13%. It is clear that this particular configuration at the Borken substation on 4 November was a very unfavourable factor. This simulation also shows that in case of outage of the Bechterdissen–Elsen line or of the Elsen–Twistetal line, the power flow over the Landesbergen-Wehrendorf line does not exceed the alarm threshold any more.
