# » Local Grid Incident in Rogowiec (Poland) substation on 17 May 2021

ICS Investigation Expert Panel » Final Report » 18 March 2022

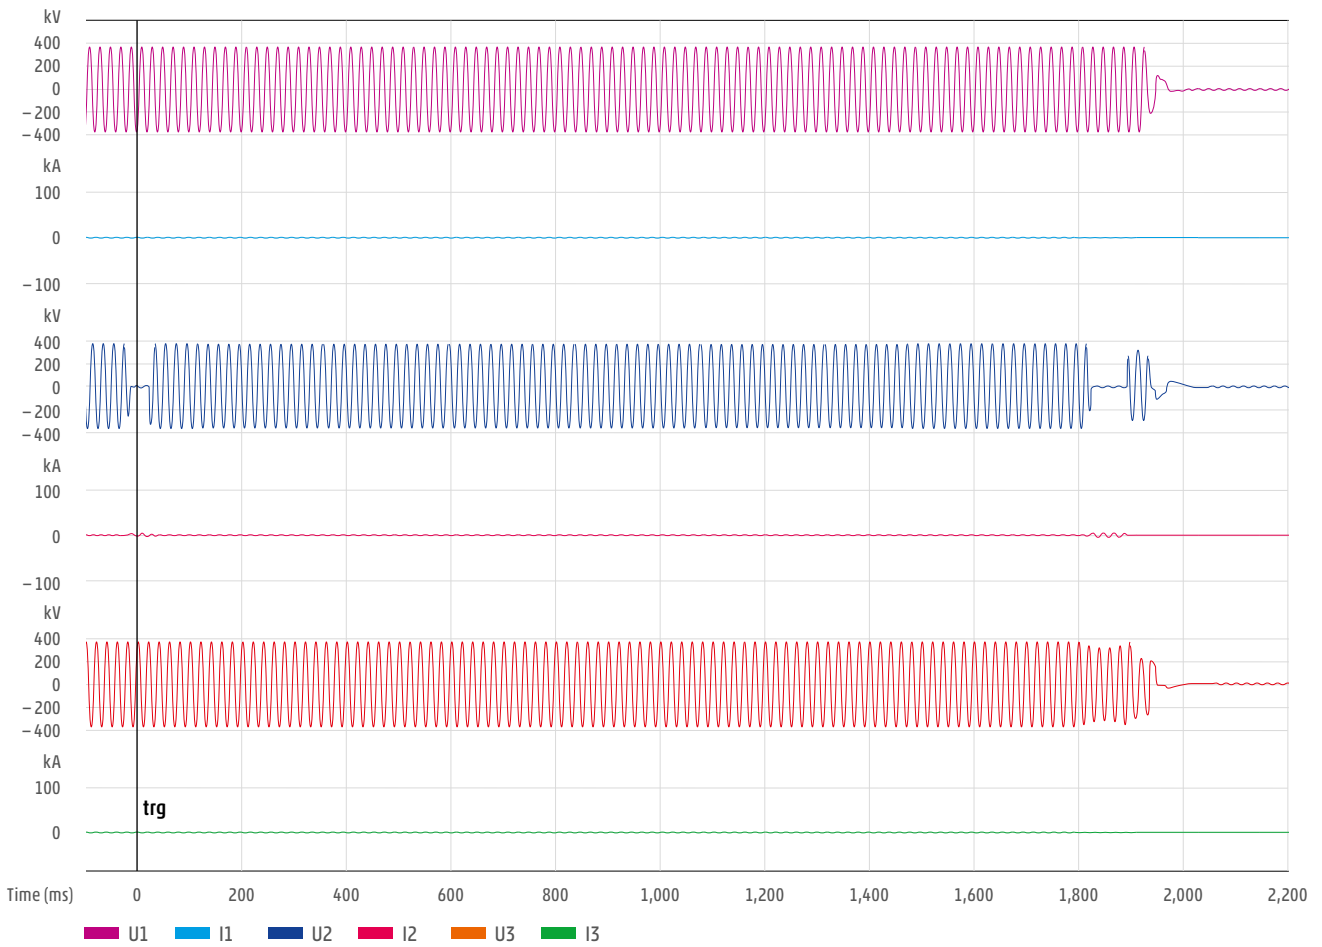
Figure 10: Measurements in the PGM BEL\_4-10 line bay at the Rogowiec substation.

At 16:34:09 TPP Bełchatów (Figure 10, PGM BEL\_4-10 as example) noticed one phase L2 short circuit voltage drop cleared by protection devices. Approximately 2 seconds later all 10 PGMs in Bełchatów noticed a loss of voltage at all 3 phases at line bays.
